WRDC-TR-89-4113

COMPUTER TOMOGRAPHY OF THERMAL BATTERIES AND OTHER  
CLOSED SYSTEMS

Boeing Aerospace Company  
P. O. Box 3999  
Seattle WA 98124

Interim Report For Period August 1988 - June 1989

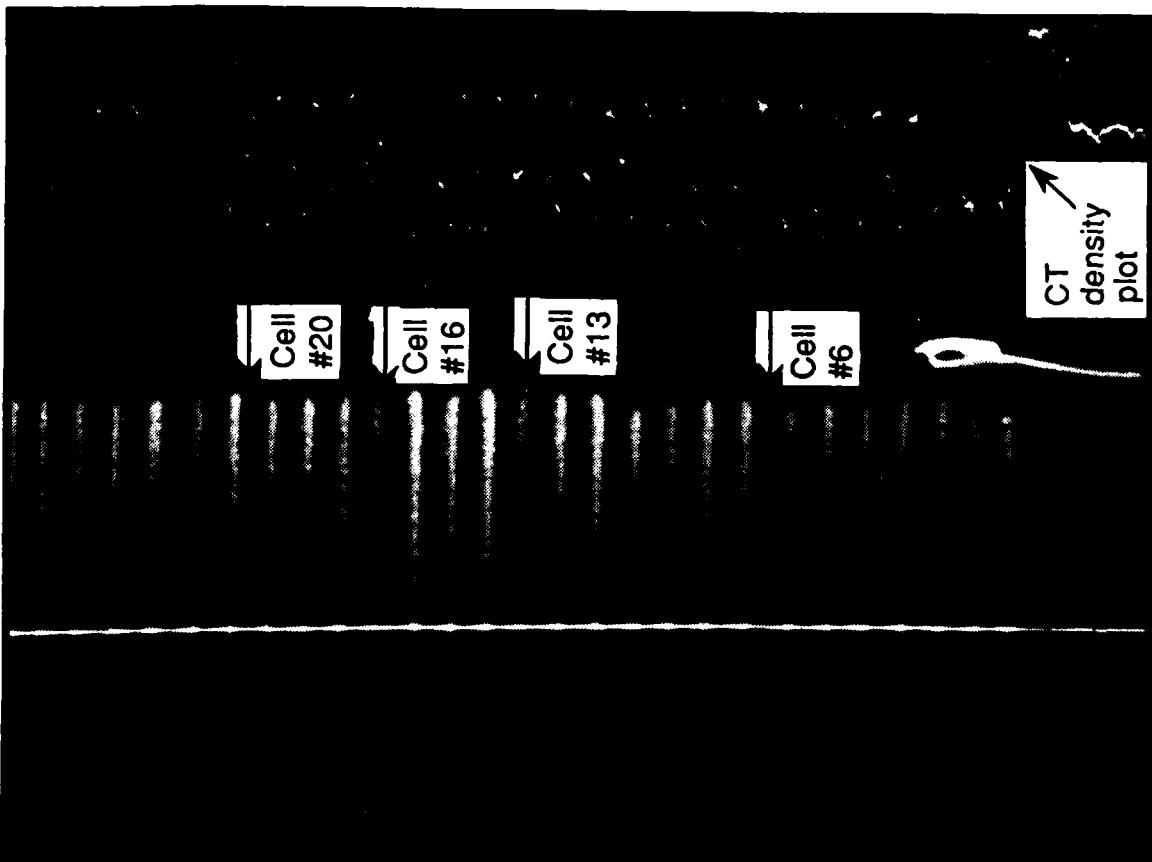
Figure 3.1-31 Ct view and density plot of anomalous cells in battery #109

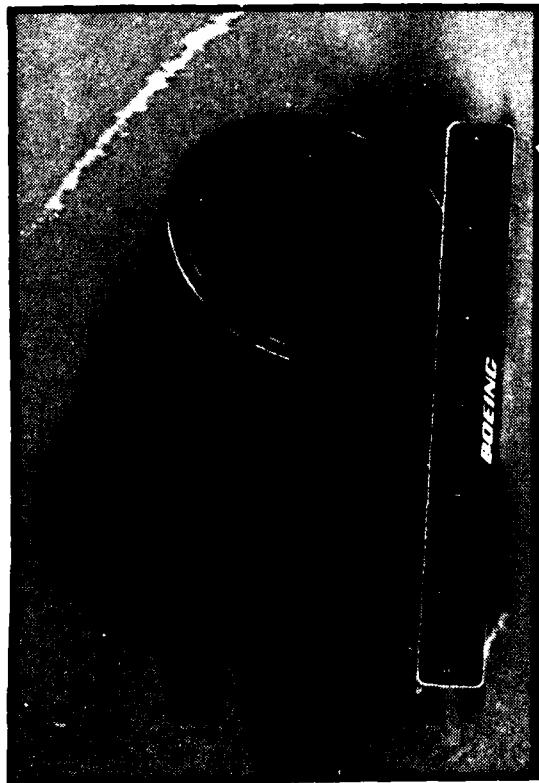
Figure 3.1-33 Fired battery #112

Battery #112 (P/N 408890), pictured in Figure 3.1-33, is identical to a companion battery, #111, except that it is fired and #111 is unfired. Figure 3.1-34 is a longitudinal CT view showing a gradation of densities in each of the relatively thick (5 mm (0.2 in)) cells. Figure 3.1-35 is a System C CT view through the fired squib of battery #112. A battery firing may produce very little recognizable differences in the radiographic image of the cells. Figure 3.1-36 is a CT image of fired battery #112, showing little internal change except for cell slump. (Note: bottom of the battery is to the right.).
